CALIFORNIA DEPARTMENT OF WATER RESOURCES

Assessment of Camp Fire Impacts to Lake Oroville

California Department of Water Resources Division of Operations and Maintenance Environmental Assessment Branch Camp Fire Water Resources Monitoring and Research Symposium June 4, 2019

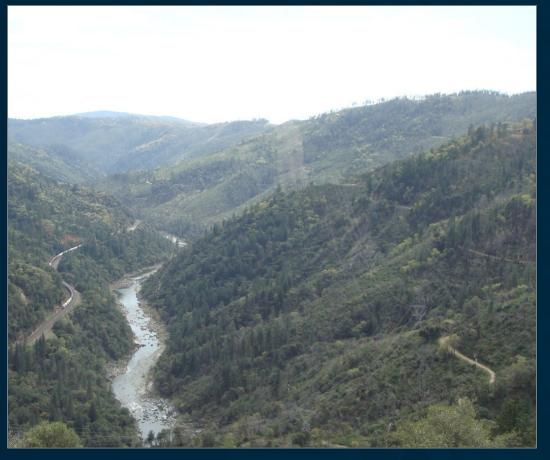
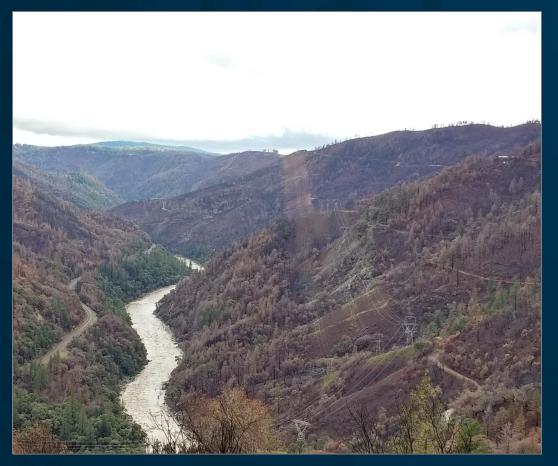
North Fork Feather River Canyon, Pre- and Post-Fire

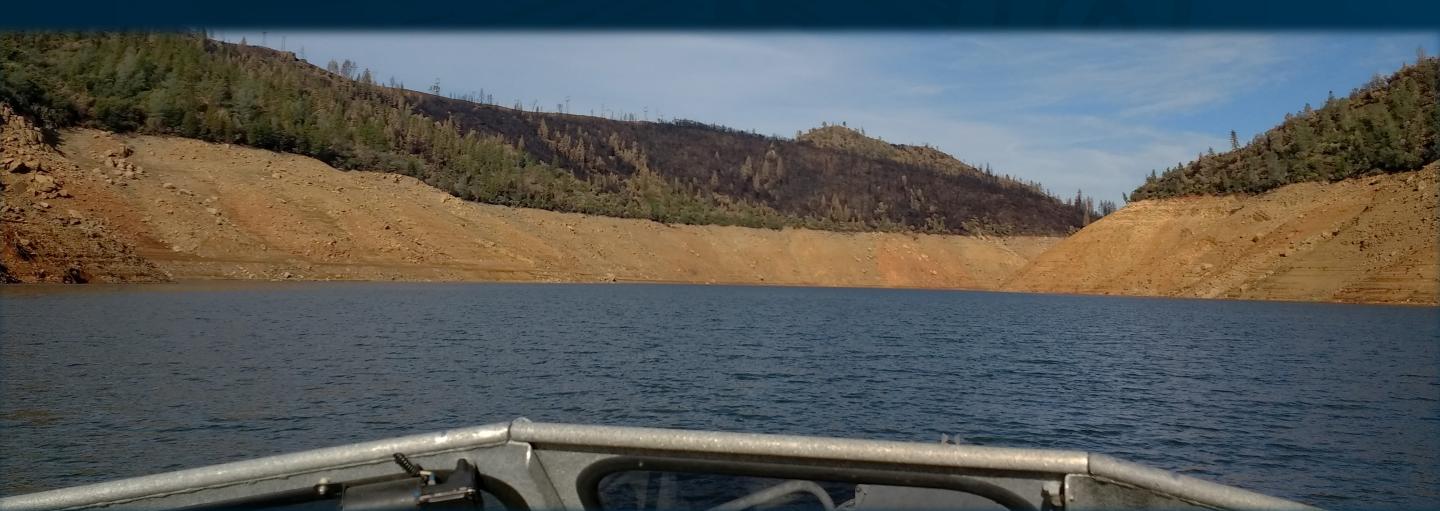
Lake Oroville & Fire Boundary

- SWP facility

Managed by DWR
- Multiple beneficial uses
 - Recreation
 - Water storage and power generation
 - Source of local drinking water
 - Terrestrial and aquatic habitat

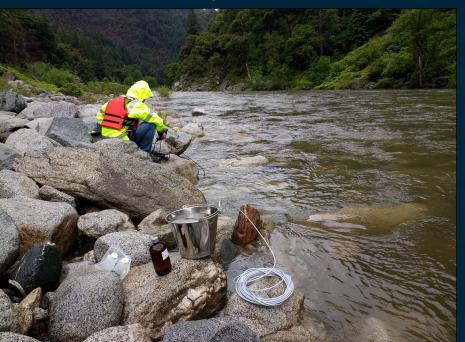
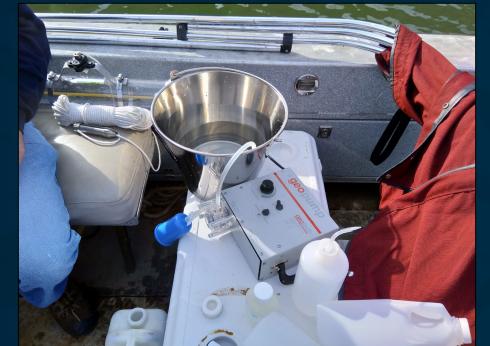
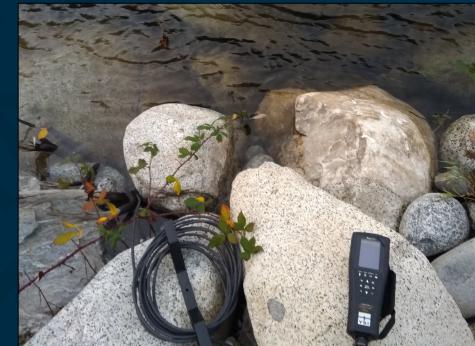
Analytes and Methods

Metals, nutrients, minerals, solids, PAHs, plus PCBs
- Collected with Van Dorn or steel bucket

Dissolved samples filtered in field
 - Analyzed at DWR's Bryte Lab or TestAmerica Labs
- Physicals measured with YSI ProDSS
