## **A Half Century of Stewardship: programmatic review of conservation by Marin RCD & partner organizations (1959-2009)**

Marin Resource Conservation District  
P.O. Box 1146, Point Reyes Station CA 94956  
(415) 663-1170, <http://www.marinrcd.org/>

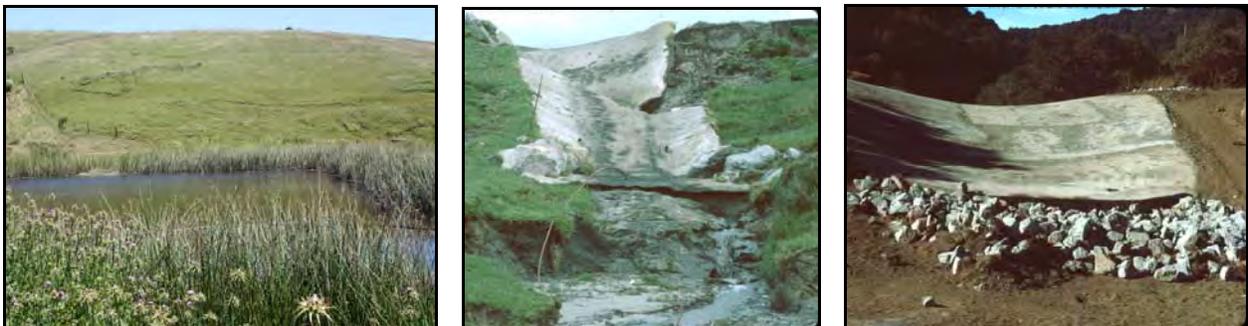
**Figure 16:** An example stockpond providing a critical source of clean water for ranch operations (left), failed spillway undermined by erosion caused by subsurface piping (middle) that was repaired by NRCS in 1985 and continues to function today (right). Photos by NRCS.

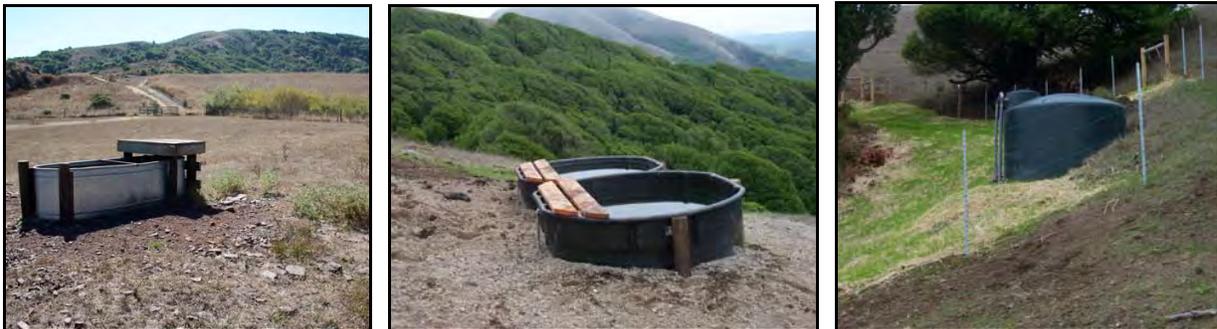
**Figure 18:** Watering facility examples in a flat combined with control fencing of the stream in background (left), and two troughs and tank combined with spring development (middle, right).

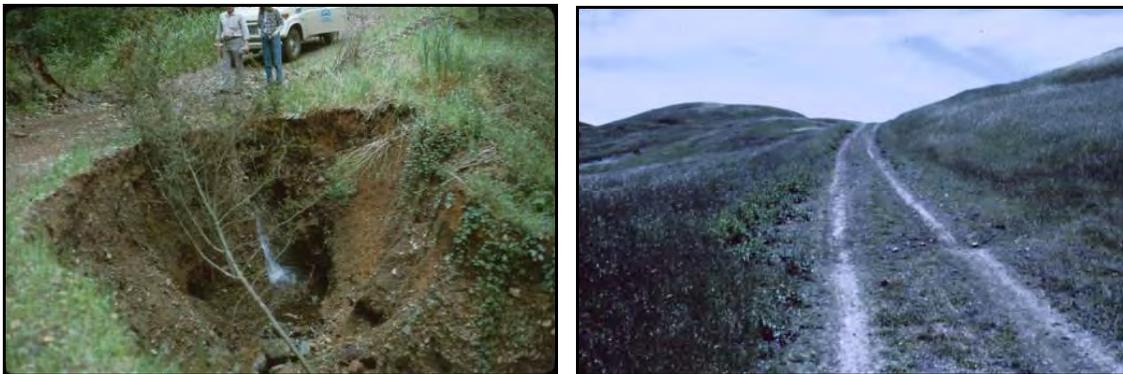
**Figure 21:** Examples of ranch road maintenance implemented in Lagunitas Creek Watershed following the 1982 flood in cooperation with Marin County Fire Department showing extensive erosion around a culvert outlet (left), and an upgraded road with out-sloped grade and water bar (right).

Access Roads provide seasonal or all year ranch and farm access for equipment and vehicles. Historically, ranch roads were constructed with inboard ditches which are now avoided. Unless well designed, installed, and managed, roads can be sources of chronic fine sediment sources and generate large volume episodic sediment pulses when culverts fail. Access road installation and maintenance by landowners, Marin RCD and partners total over 70,943 feet, with much of this occurring in the Lagunitas Creek Watershed following the 1982 storm (Figure 21). This included road out-sloping, installing water bars, upgrading culverts or stream crossings, decommissioning selected road segments, and stabilizing ditches constructed by Marin County Fire Department and designed by Prunuske Chatham, Inc.. Due to past logging activities, Lagunitas Creek Watershed had a greater density of rural roads than Walker Creek Watershed and, consequently, more road related erosion occurred in the 1980s.

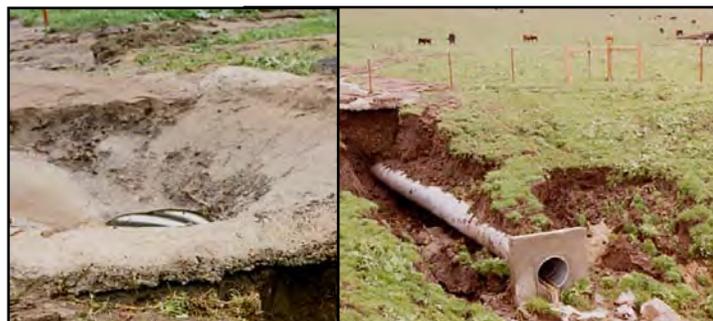
Sediment plugged inlet caused failure of Water Control Structure.

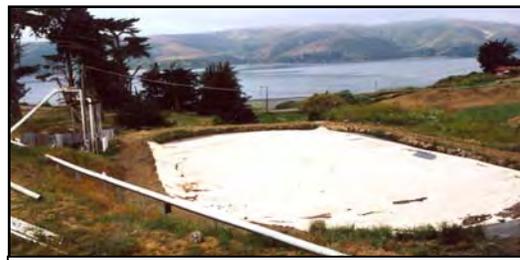
Methane digester pilot project.

Each dairy facility generally consists of manure settling ponds to collect solid material before the liquid enters a secondary lagoon from which it may be applied to pastures at appropriate times. These systems have been expanded in capacity over the years with at least 45 Settling Ponds and 64 Lagoons constructed. In 1999, Marin RCD initiated a methane digester pilot project by retrofitting and covering a lagoon to create anaerobic conditions with a grant for Advanced

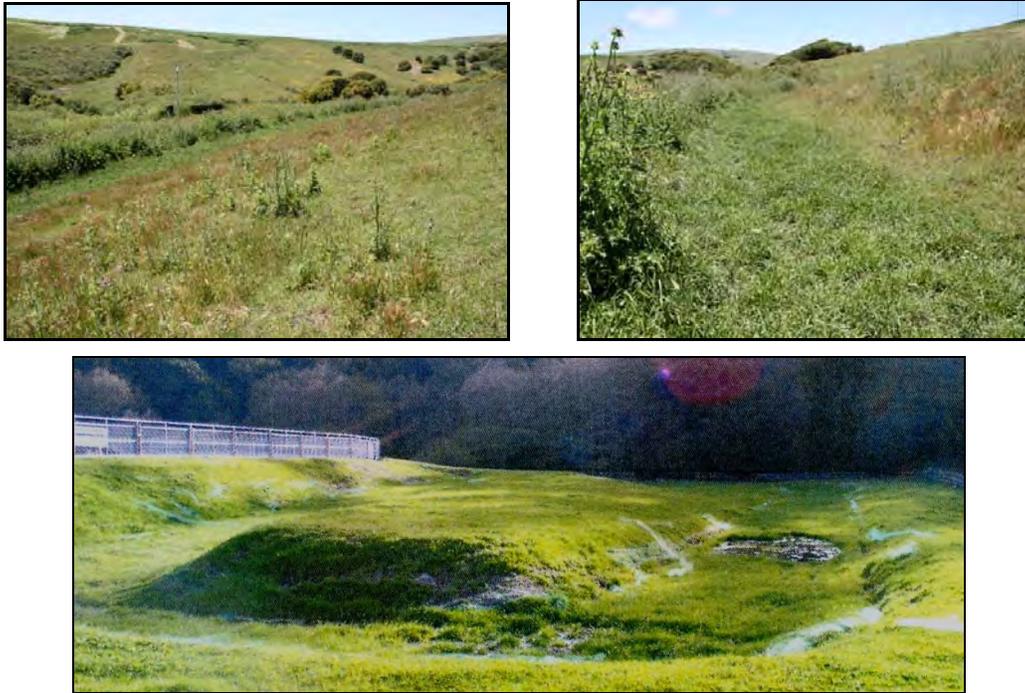
**Figure 23:** Examples of Filter Strips to treat surface water runoff from corrals depicting an overview of a hillside site with over 400 feet of laminar flow conditions following the contour (top), and a flat bottomland location where the site's treatment distance and laminar flow conditions were maximized (bottom). Designed by NRCS.

Filter Strips are wide ditches that maximize laminar flow conditions designed to collect sediment and filter pollutants from small drainages within the ranch or farm, such as stormwater runoff from corrals or dry lots. This practice was historically implemented to filter wastewater as an alternative to waste management systems. In cases where herd size grew, treatment capacity was often overwhelmed by the increased supply of manure. Marin RCD and partners have responded to these changing capacity requirements and challenges to installation at specific locations in order to provide maximum length with appropriate gradients on hillside and lowland locations (Figure 23). Filter strips provide an ideal option for high functioning vegetative buffers to reduce pathogens in stormwater runoff (Lewis et al. 2010, Lewis et al. 2009, Tate et al. 2006, Tate et al. 2004).

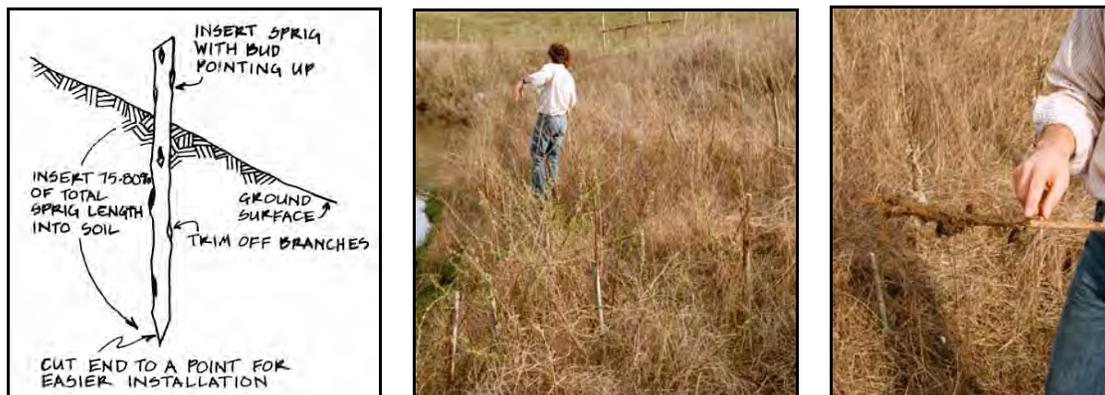
**Figure 24:** The specification for planting a willow cutting or sprig and surveying a newly planted site with some rabbit damage in 1988 (top). Design and photos by Prunuske Chatham, Inc.

Critical Area Planting incorporated revegetation technologies using willow that were tested in the 1960s and 70s to fix gully erosion by Marin landowners with the assistance of NRCS. In the 1980s, willow became regularly incorporated into Marin RCD practices as soft approaches that allow for shifting and settling of soil, but provide for long-term site stability (Figure 24). This includes tree planting as cuttings, sprigs or poles and “bioengineering” or “biotechnical” specifications of high density willow woven into a wall, mattress, wattle, or brush layer as living checkdams or headcut repairs as described in *Groundwork* (Prunuske 1987). These soft approaches to channel stabilization and streambank protection have been improved upon over the last 30 years by Marin RCD and its partners to now offer an effective, low cost option that has proven successful in Marin County conditions.

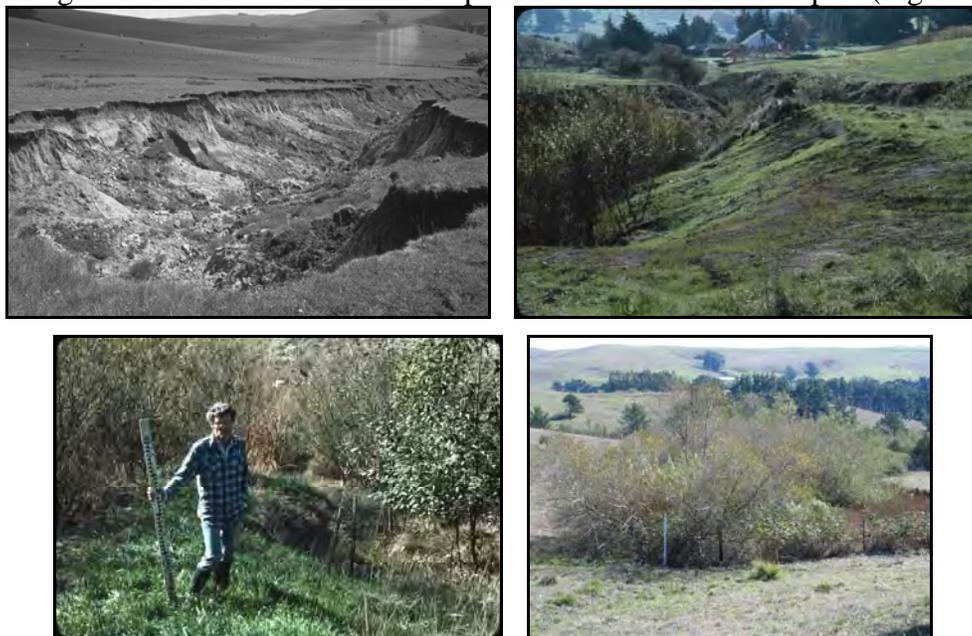
**Figure 27:** Some of the “worst erosion in Marin County” was like this Walker Creek property when channel stabilization and revegetation began in 1970 (top left), nine years later streambanks are more stable with trees establishing (top right), the project leader posing with successful plantings (bottom left), and 35 years later the gully is completely stable with diverse habitat including arroyo willow, shining willow, red alder and other shrub species (right). NRCS Designed.

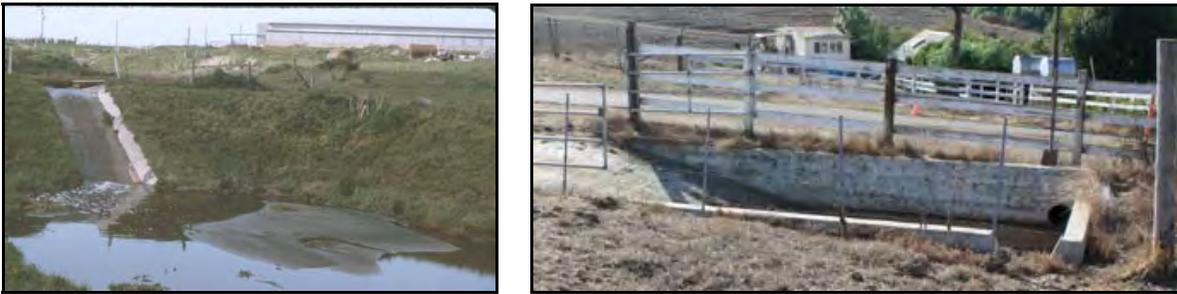
**Figure 29:** Examples of Sediment Basins depicting a large-scale design constructed in the 1980s (left), and a smaller version with a paved access ramp to facilitate maintenance built in 2005 (right).

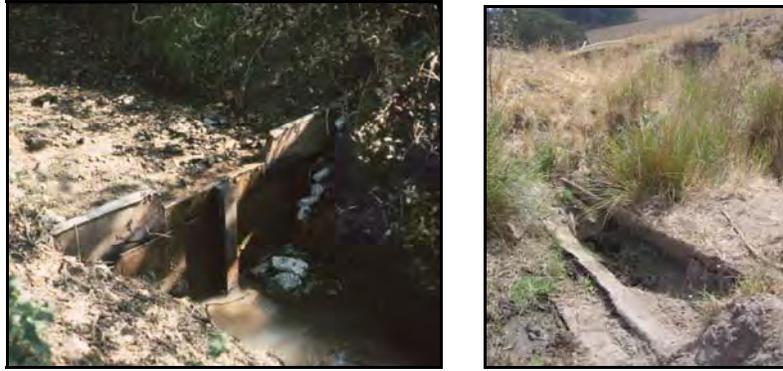
**Figure 30:** Examples of redwood board checkdams used as Grade Stabilization Structures with a recently constructed site in the 1980s (left), and a 30 year old site with deteriorated checkdam but vegetation such as *Juncus* has stabilized potential soil erosion (right). Designed by NRCS and Prunuske Chatham.

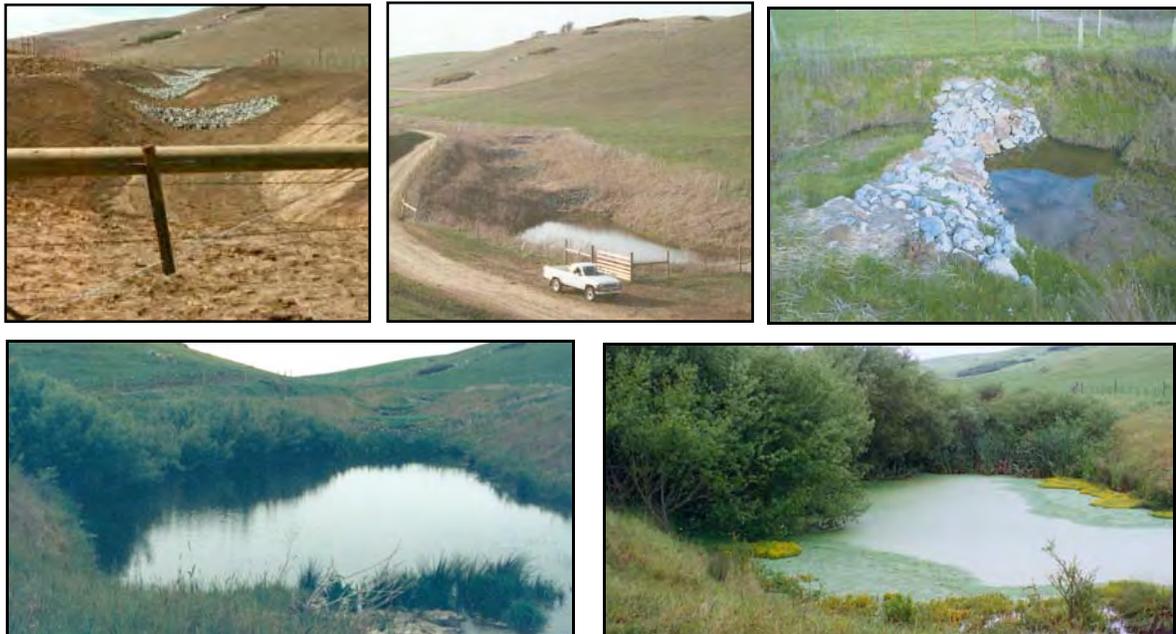
**Figure 31:** A series of seven small Grade Stabilization Structures were installed in the gully as loose rock checkdams above a Sediment Basin in 1989 with preproject photo (top left), aerial view design (top right), immediately following construction (middle left), the site two years later (middle), checkdam structure functioning as designed (middle right), four years (bottom left), and six years later (bottom right). Designed by Prunuske Chatham and NRCS.

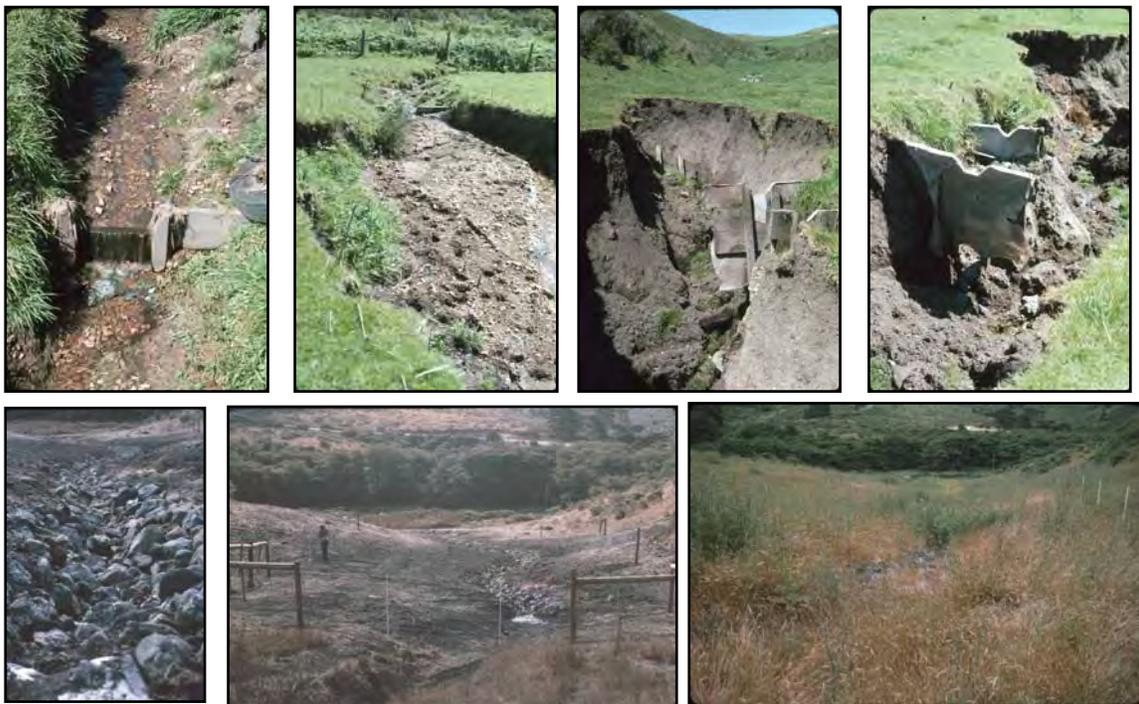
**Figure 32:** Photo monitoring of a grade stabilization project with functional redwood board checkdams before March 1986 storms (top left 2 photos), following March 1986 storms (top right 2 photos), the emergency repair installed a Lined Waterway with control fencing (bottom left 2 photos), and one year later in June 1987 (bottom right). Designed by NRCS.

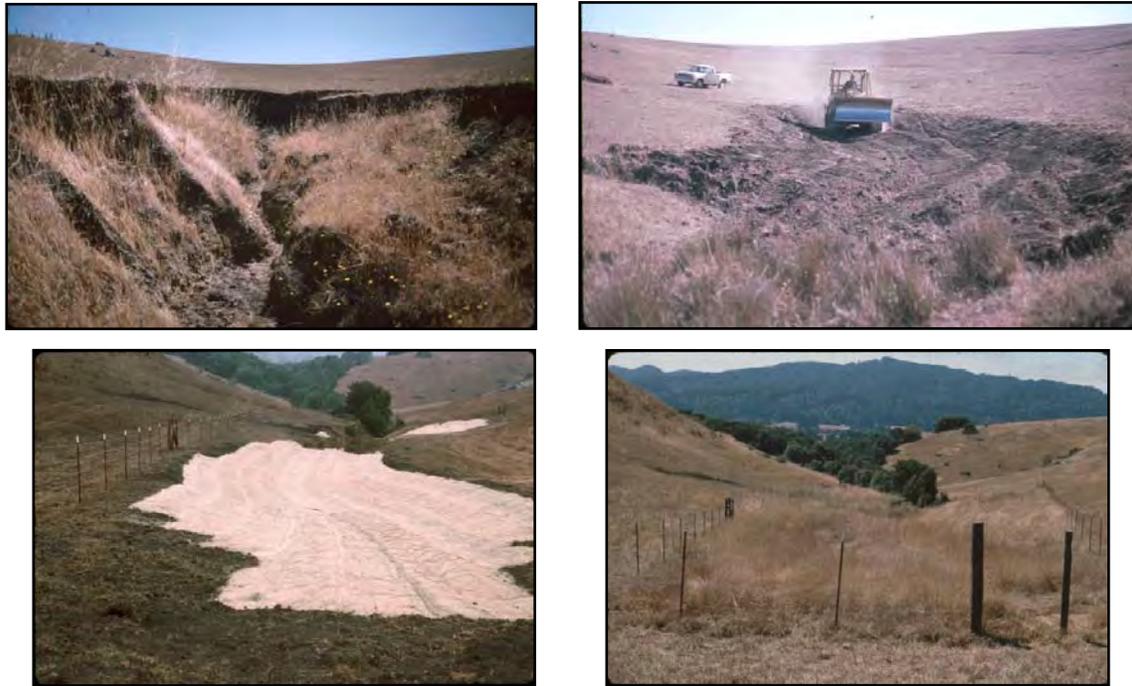
**Figure 33:** A Grassed Waterway practice installed in Lagunitas Creek Watershed in 1988. Designed by NRCS.

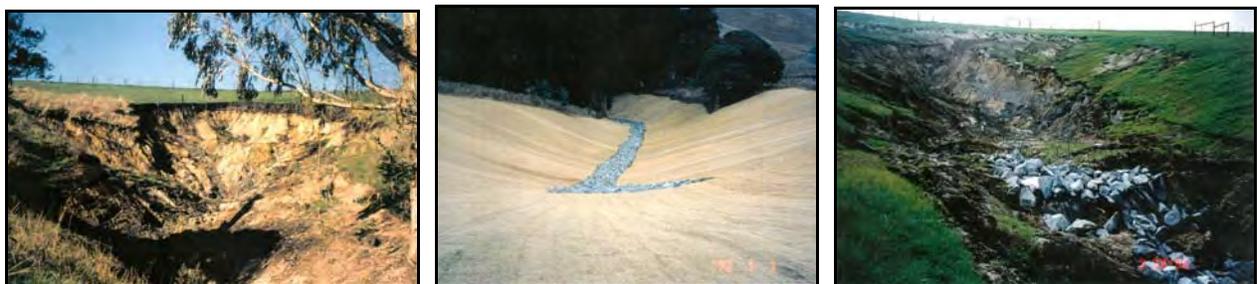
**Figure 34:** An eroding gully pre-project (left), after implementation of Lined Waterway and other practices in 1992 (middle), and four years later the site had unraveled (right).
